# Bridge inspection technique using rope access

*Hanshin expressway engineering Co.Ltd.*

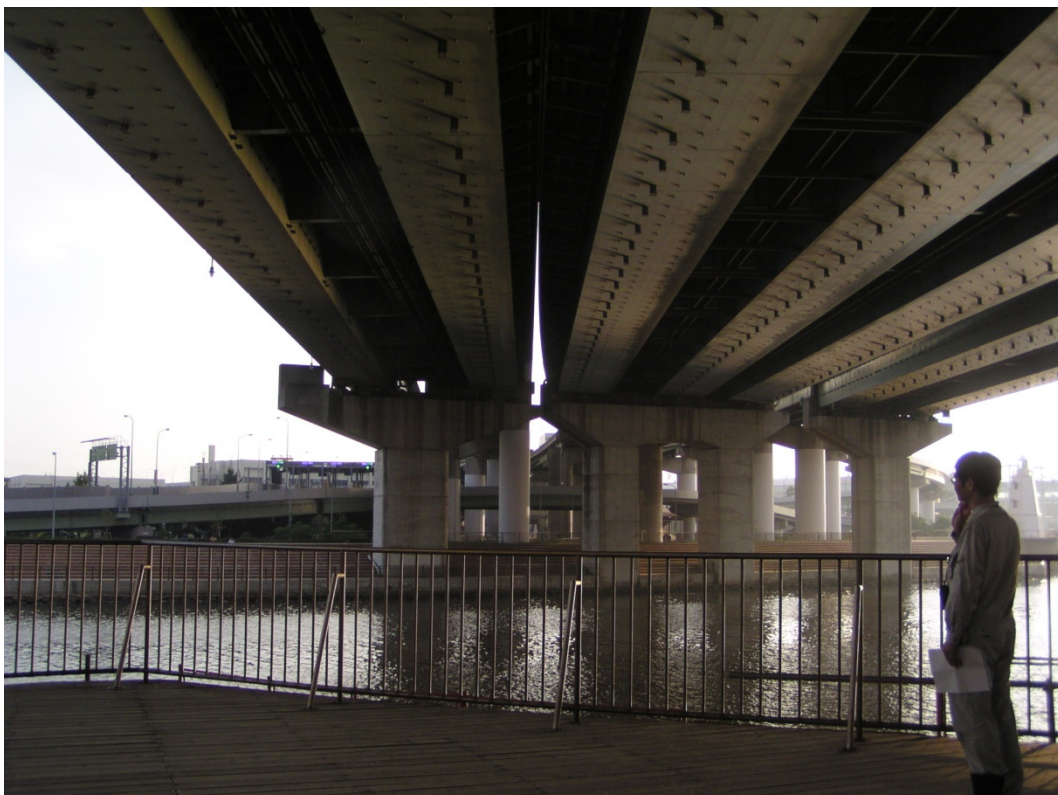
Photo 1, The bridges inaccessible by gondola lift vehicles or bridge inspection vehicles

Inspection of all steel deck bridges started in 2003 on the Hanshin Expressway after fatigue cracks were found in steel decks that is the upper flange of the box girders during periodic regular inspection in 2001. Steel decks of most of the bridges were inspected using catwalks, ladders, gondola lift vehicles and bridge inspection vehicles. However, the members inaccessible by these ways are left uninspected. Most of these places are located over a river, sea and in the vicinity of a ramp, junction, toll gate or parking area. For such members, temporary scaffolding is erected conventionally just for inspecting.

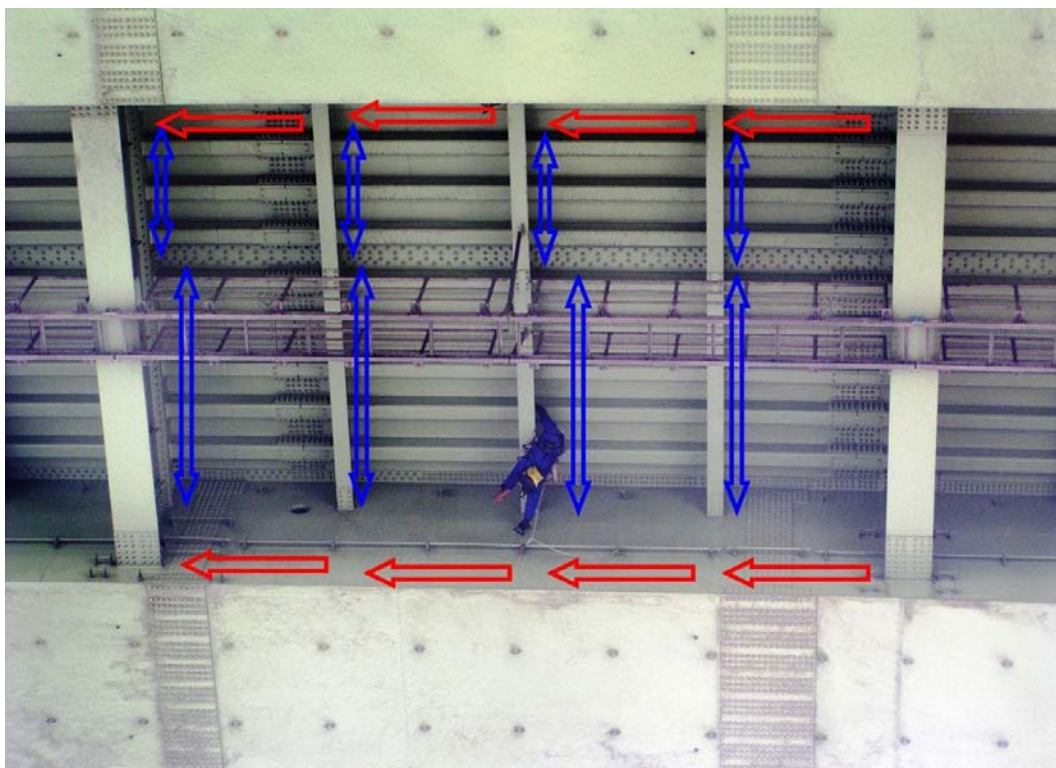
Photo 2, Work procedure of steel deck inspection by rope access technology

Photo 2 shows the work procedure. The arrows indicate the directions in which the inspector travels: longitudinal direction in red; and transverse direction in blue.

installment of scaffold for re-painting were used. The hanger hooks attached to the main girders for re-painting were used for longitudinal travel support, while transverse travel was supported by routing the ropes around the scallops at the corner of the web and flange plates. Transverse rib plates were spaced mostly at intervals of about 3 m, and the inspectors move these spaces between the ribs covering by extending arms from the ribs.

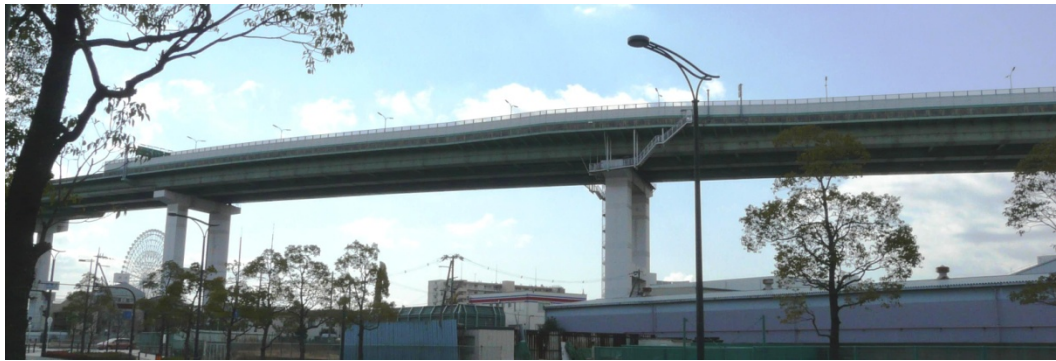
Photo 3, Test field location

The field test area was the center span of a 3-span continuous steel deck box girder bridge on the Wangan Route of the Hanshin Expressway, excluding the interior of the box girders.

The span length was 111 m, and inspection area was about 2,100 m<sup>2</sup>. The Wangan Route which links bay areas in Osaka and Kobe was built on soft reclaimed lands. Steel decks were adopted for minimizing dead load of the structures. Being located close to coastal facilities, the route plays an important role in land transportation. Heavy traffic of container trailers and large vehicles causes severe condition for structures. The current inspection area was found to have weld cracks at four locations in steel deck plates and longitudinal ribs during the regular inspection performed one year ago.

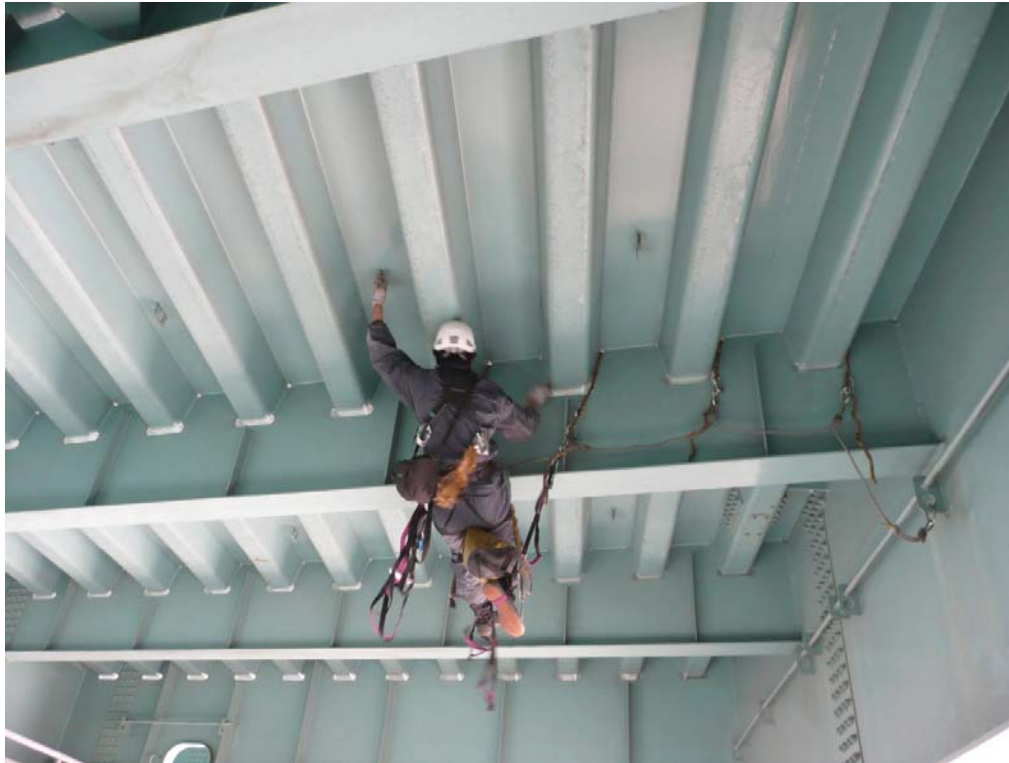
Photo 4, Conditions of inspection

Photo 4 shows a view of the operation of inspection. Figure 3 shows the inspection area specified for the 5 work days. The shaded portions indicate the area actually inspected. About 1600 m<sup>2</sup> was inspected in the 5 work days, with an average of 320 m<sup>2</sup> per day. The work volume was influenced by the shape of the main girders, cross beams, transverse ribs, scallops, catwalks, and drainage pipes.

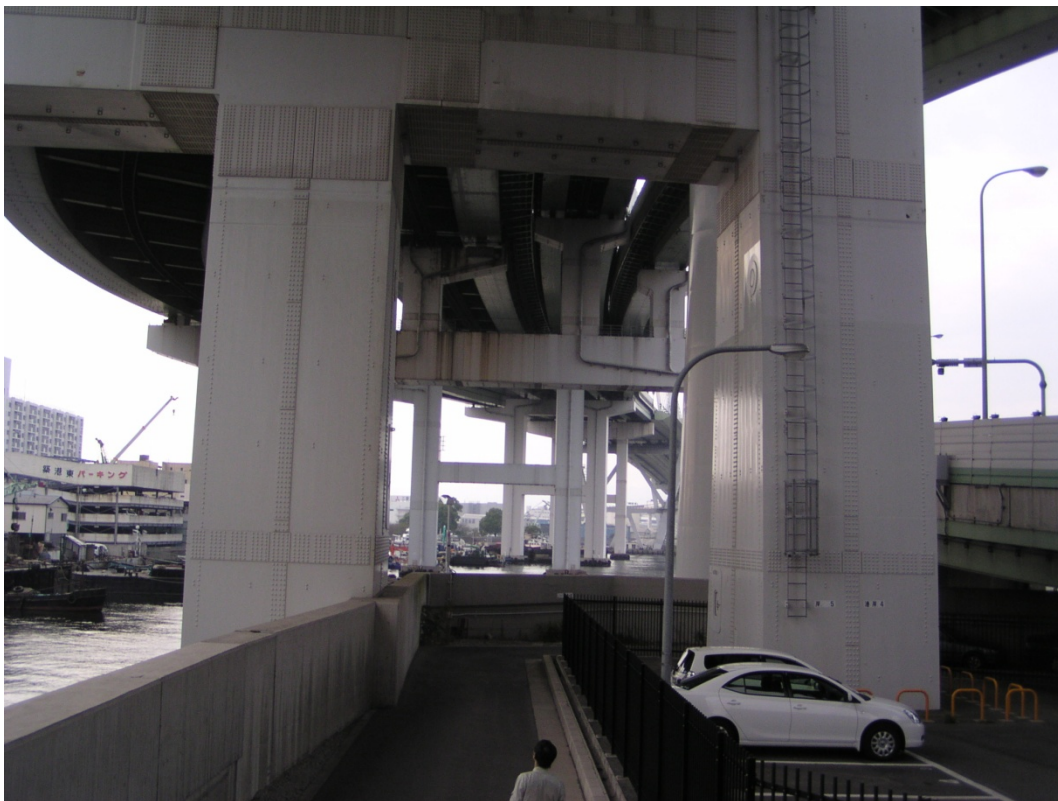
Photo 5, The one location that inspected by rope-access-technique

With the problems with rope access solved by the field test, the technique was tested on the structures in service. Steel deck inspection was carried out on 33 spans or about 30,000 m<sup>2</sup> in total using rope access technique, and fatigue damage was detected at 54 locations, at accuracy comparable to ordinary inspection.

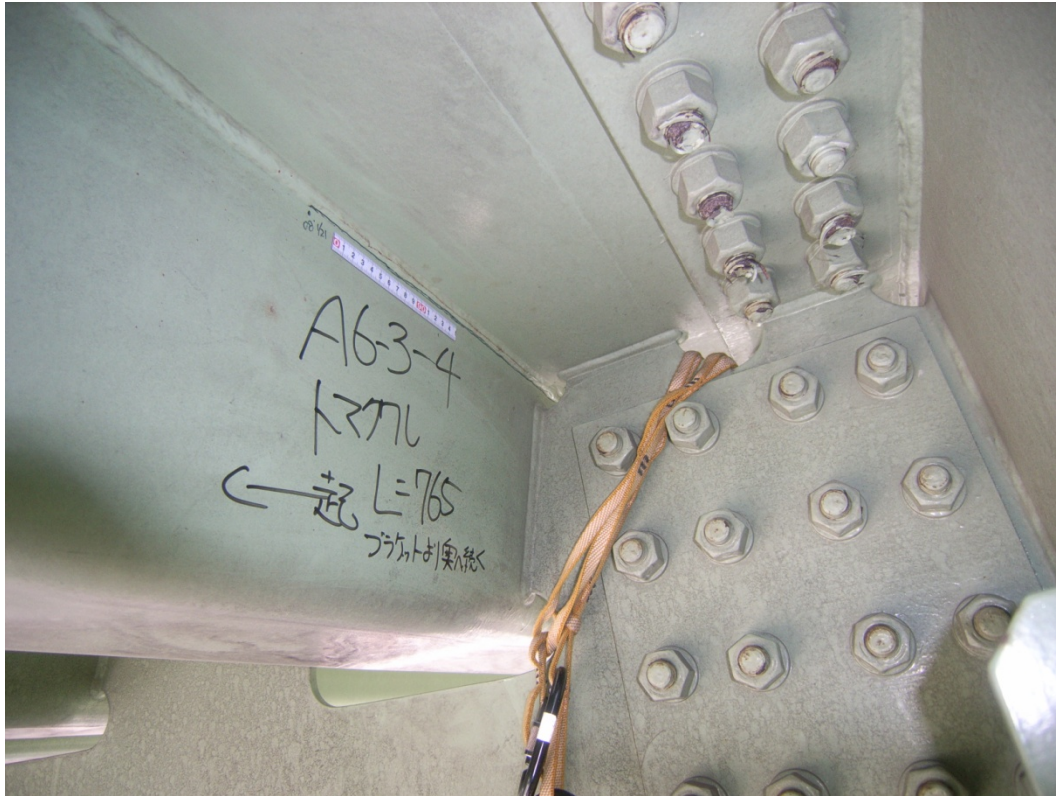
Photo 5, The one of detected crack
